**THESIS**

**FAULT ASSESSMENT OF A DIESEL ENGINE  
USING VIBRATION MEASUREMENTS AND  
ADVANCED SIGNAL PROCESSING**

Robert A. Armstrong

December 1996

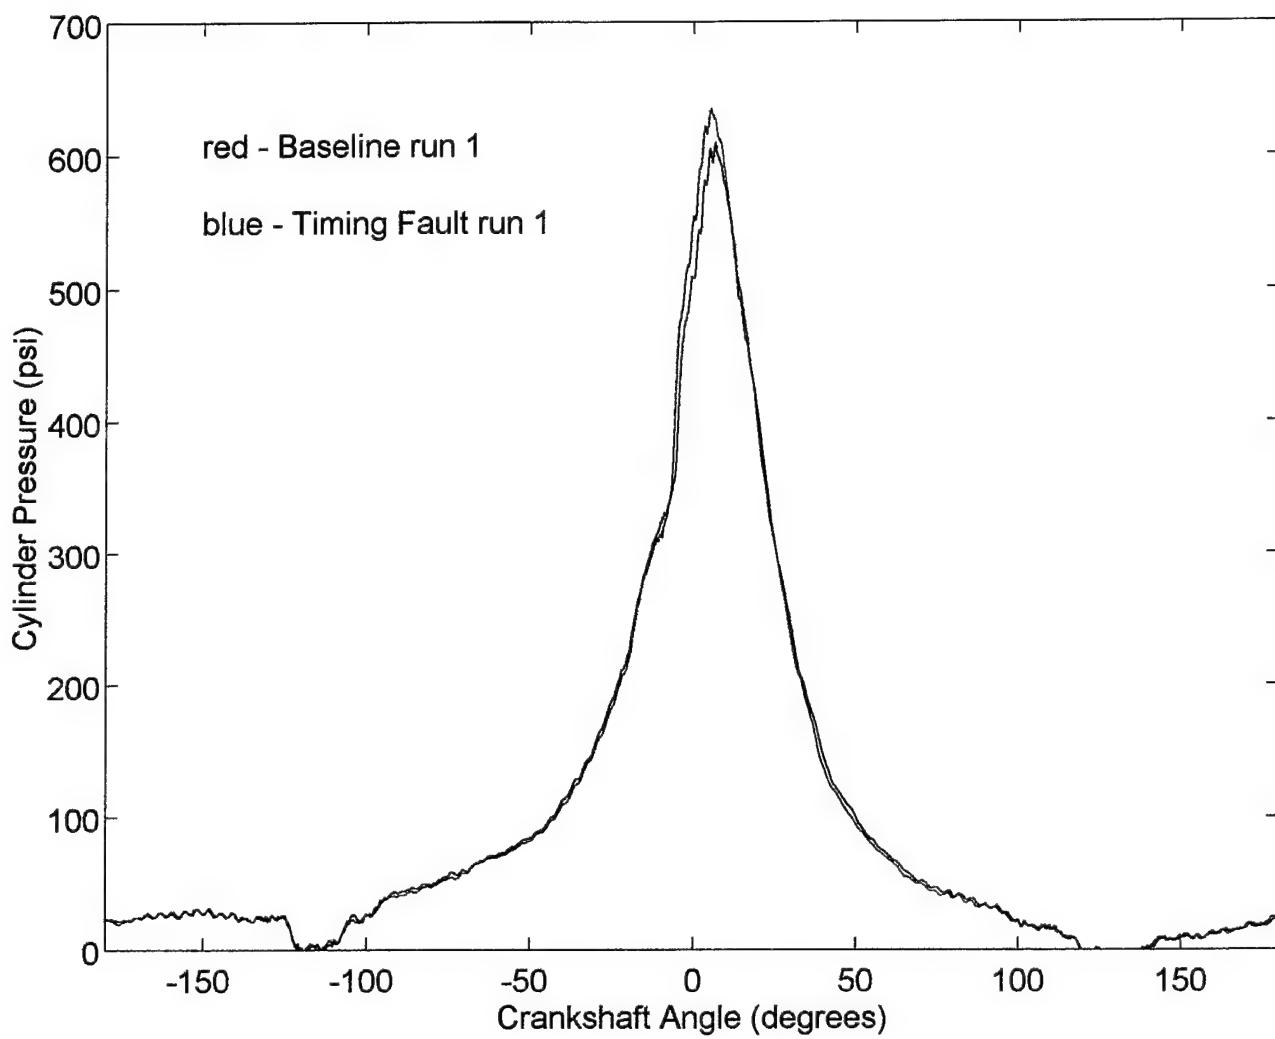
Figure 4.1 Cylinder pressure data plot for the complete revolution

The data for the #1 cylinder pressure are plotted in Figure 4.1 and Figure 4.2. Figure 4.1 shows the complete engine cycle for one baseline data set and one timing fault data set. The bottom axis is the crankshaft angle from  $-180^\circ$  to  $+180^\circ$ . Several engine events are clearly distinguishable. Starting from the left, the intake ports and the exhaust valve are both open. The initial pressure level is due to the air intake blower forcing air through the cylinder. At  $-120^\circ$  the intake ports are closed off by the movement of the piston and the pressure in the cylinder drops to atmospheric pressure. At  $-110^\circ$  the exhaust valves close and the pressure begins to rise. The pressure peaks just after TDC. The baseline curve has a higher peak pressure than the timing fault curve, as expected. The pressure curves then fall as the piston moves down in the cylinder. At  $+110^\circ$  the exhaust valves open and the pressure drops to atmospheric pressure. The intake ports open at  $+140^\circ$  and air is again forced through the cylinder by the blower.

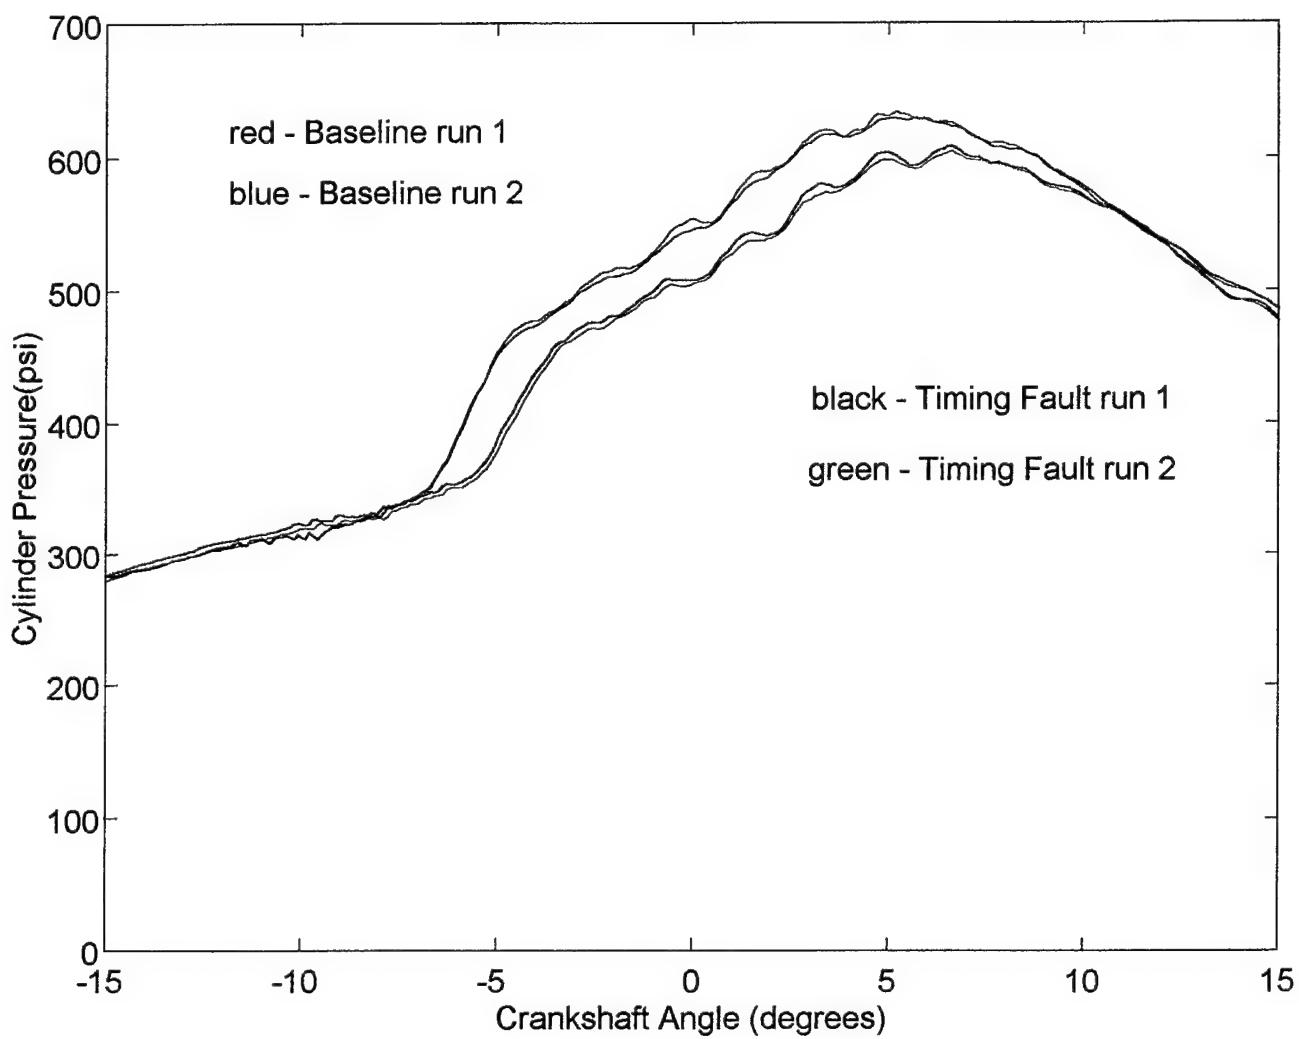
Figure 4.2 Cylinder pressure detailed plot

In Figure 4.2 two sets of baseline data and two sets of timing fault data are plotted. The bottom axis is adjusted to display the firing of the first cylinder. The four curves are nearly identical until the fuel injection occurs. The pressure rise associated with combustion is clearly visible. There is a  $2^\circ$  difference in the start of combustion between the baseline curves and the timing fault curves. The peak pressure point for the timing fault curves has shifted to the right and is 25. psi lower.

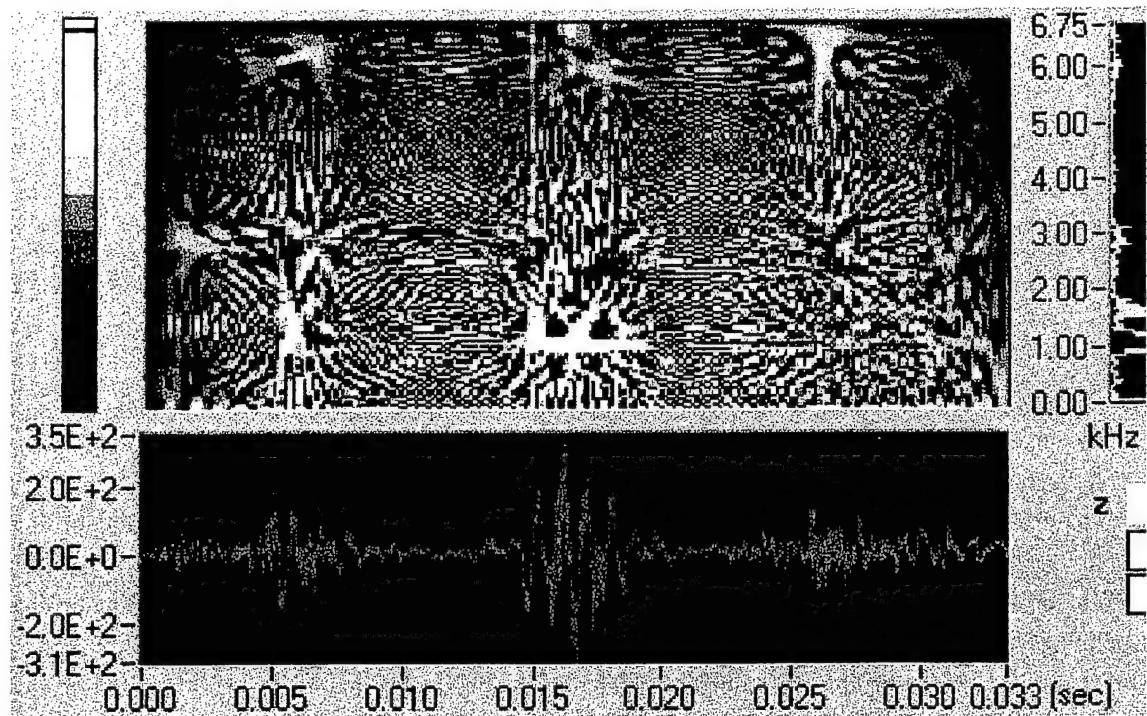
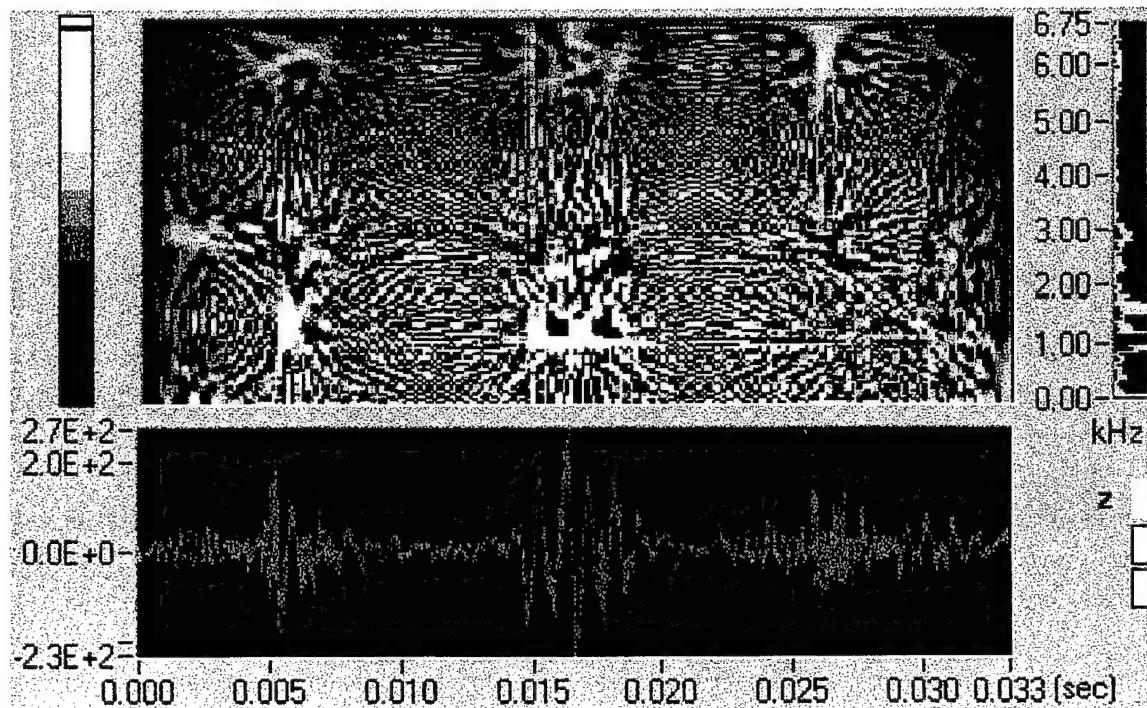
Figure 4.3 shows the WVD of the baseline vibration signal. The timing fault condition vibration signal is shown in Figure 4.4. These WVD figures show very fine time and frequency resolution. However, the cross term interference and noise levels of the signals causes the display to be very cluttered. Except for the main energy peak at 1 khz and 0.0165 seconds, it is difficult to determine which frequencies are truly present in the signal. The WVD provides little or no useful information in determining the differences between the baseline and timing fault signals.

Figure 4.3 Wigner-Ville Distribution of the engine baseline vibration signal

Figure 4.4 Wigner-Ville Distribution of the engine timing fault condition vibration signal

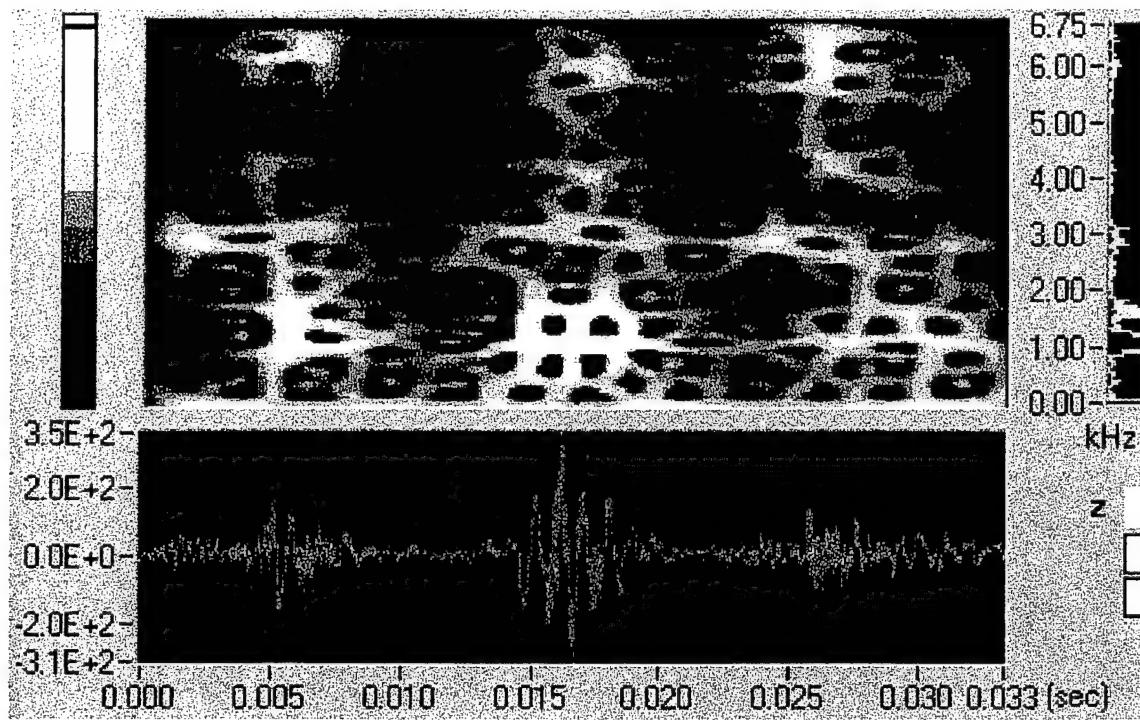
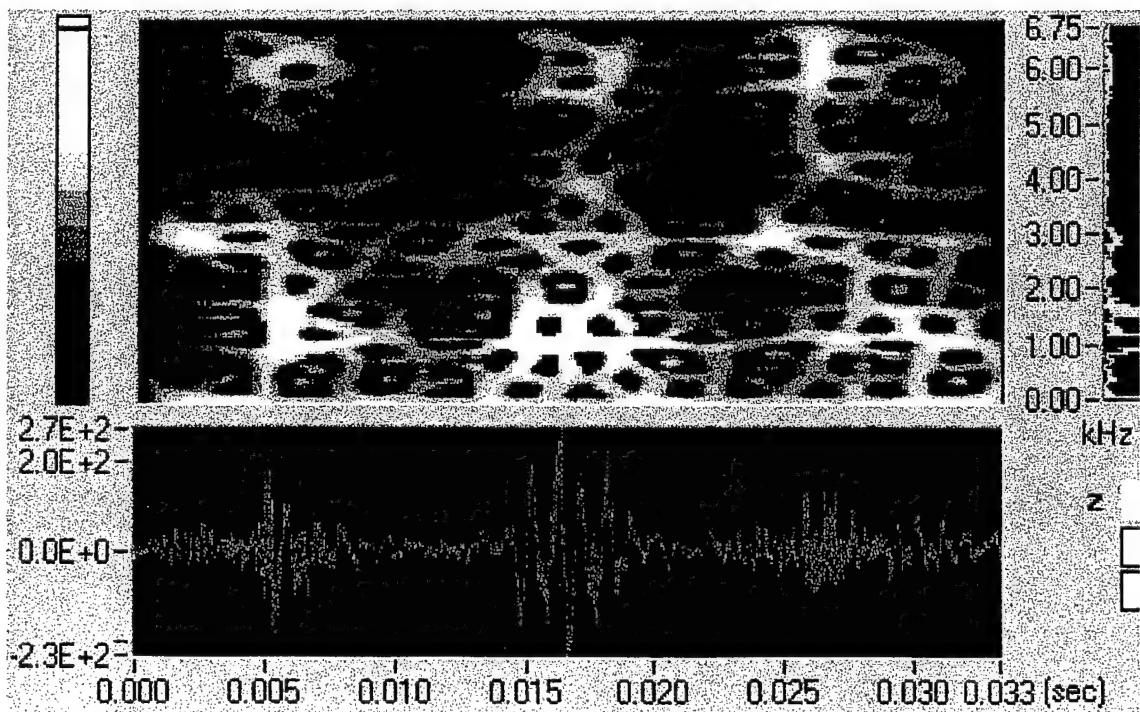
Figure 4.5 shows the Gabor Spectrogram of the baseline vibration signal. The timing fault condition vibration signal is shown in Figure 4.6. The Gabor representations do not have the fine time and frequency resolution displayed in the WVD figures. The effects of cross term interference and noise are reduced but still present. Again there is little detectable difference between the baseline and timing fault signal spectrograms.

Figure 4.5 Gabor Spectrogram of the engine baseline vibration signal

Figure 4.6 Gabor Spectrogram of the engine timing fault condition vibration signal

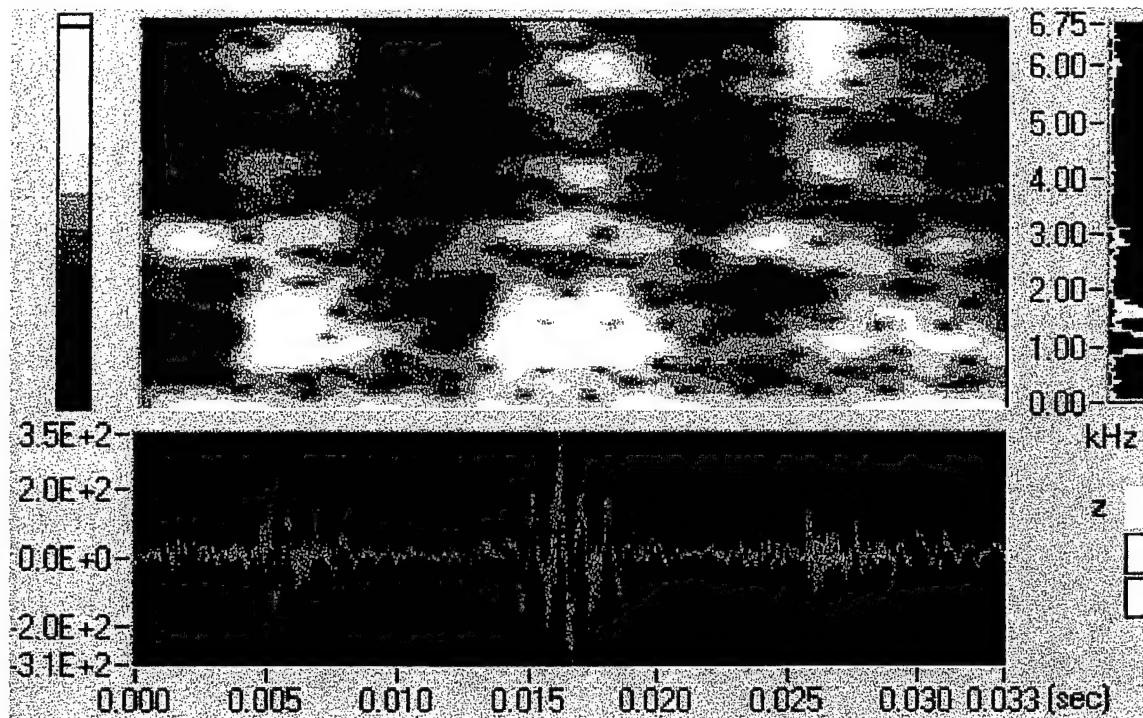
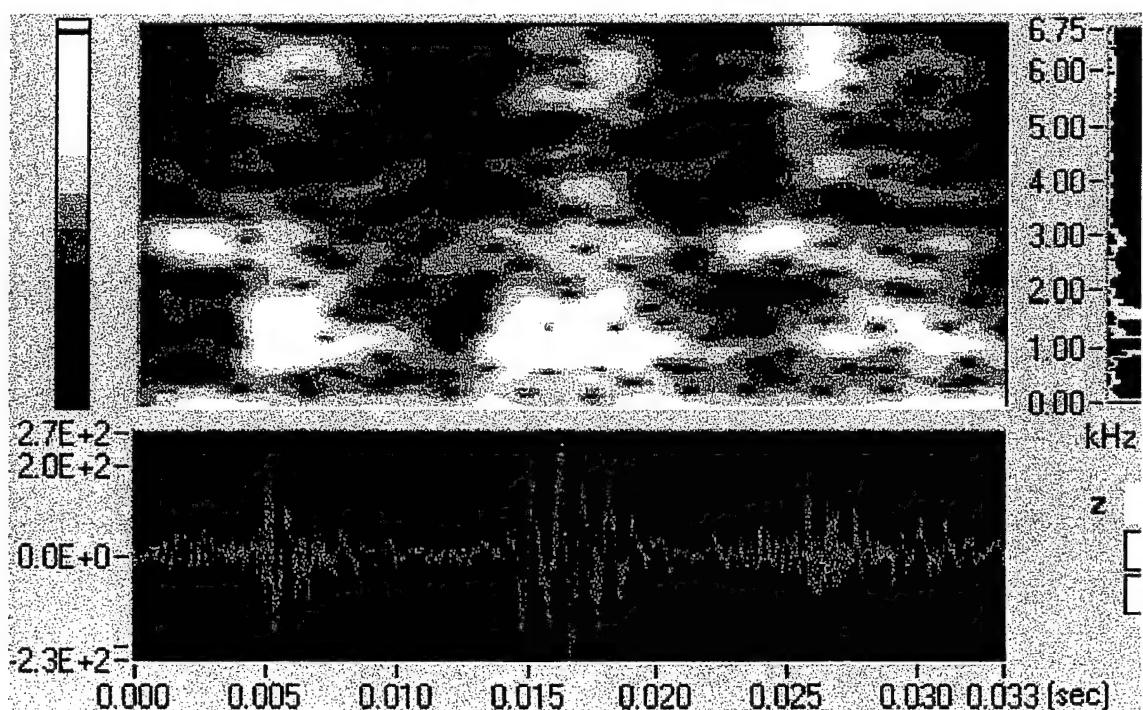
Figure 4.7 shows the STFT of the baseline vibration signal. The timing fault condition vibration signal is shown in Figure 4.8. The STFT does not have any cross term interference, but does show the background noise level in the dark orange-red areas. Concentrating on the center of the time domain where the first cylinder is firing at 0.016 seconds, there are some differences between the baseline and timing fault signal displays. The energy peak at 3 khz appears to have shifted to the right 0.003 seconds. The 6 khz energy peak magnitude has a lower value in the timing fault distribution than the value in the baseline distribution. The fundamental problem with the STFT is that tradeoffs must be made between time resolution and frequency resolution. However, this method does provide a useful display of the time and frequency content of the signal.

Figure 4.7 Short-Time Fourier Transform of the engine baseline vibration signal

Figure 4.8 Short-Time Fourier Transform of the engine timing fault condition vibration signal

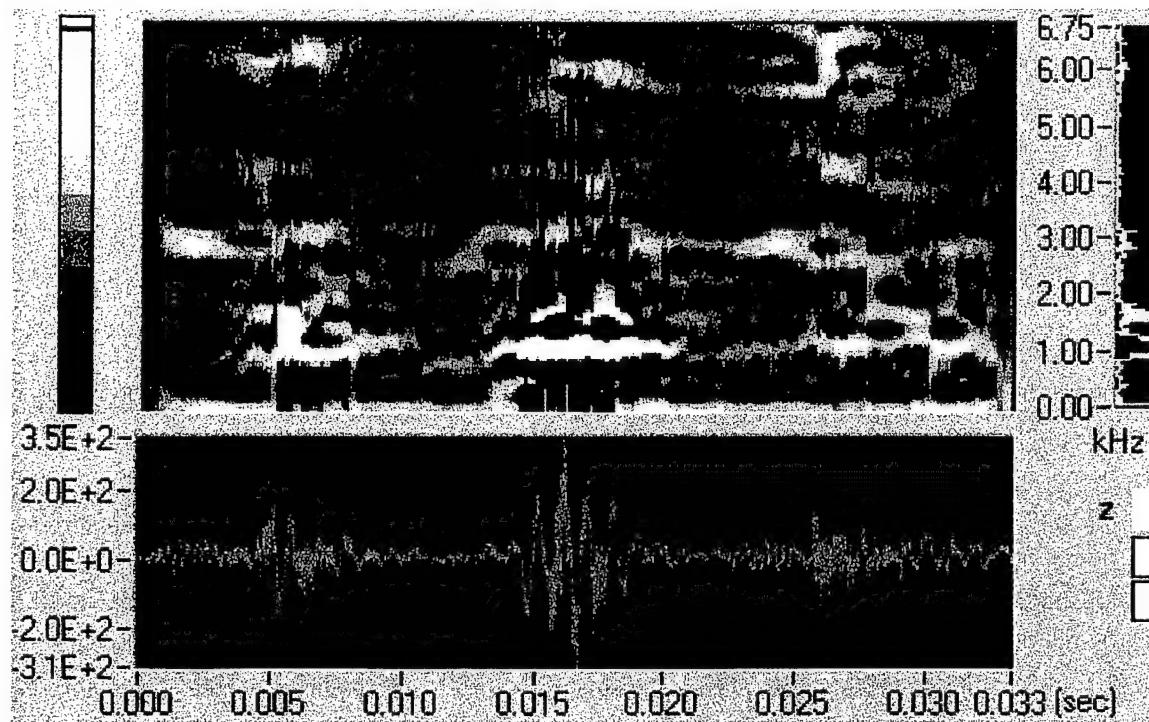
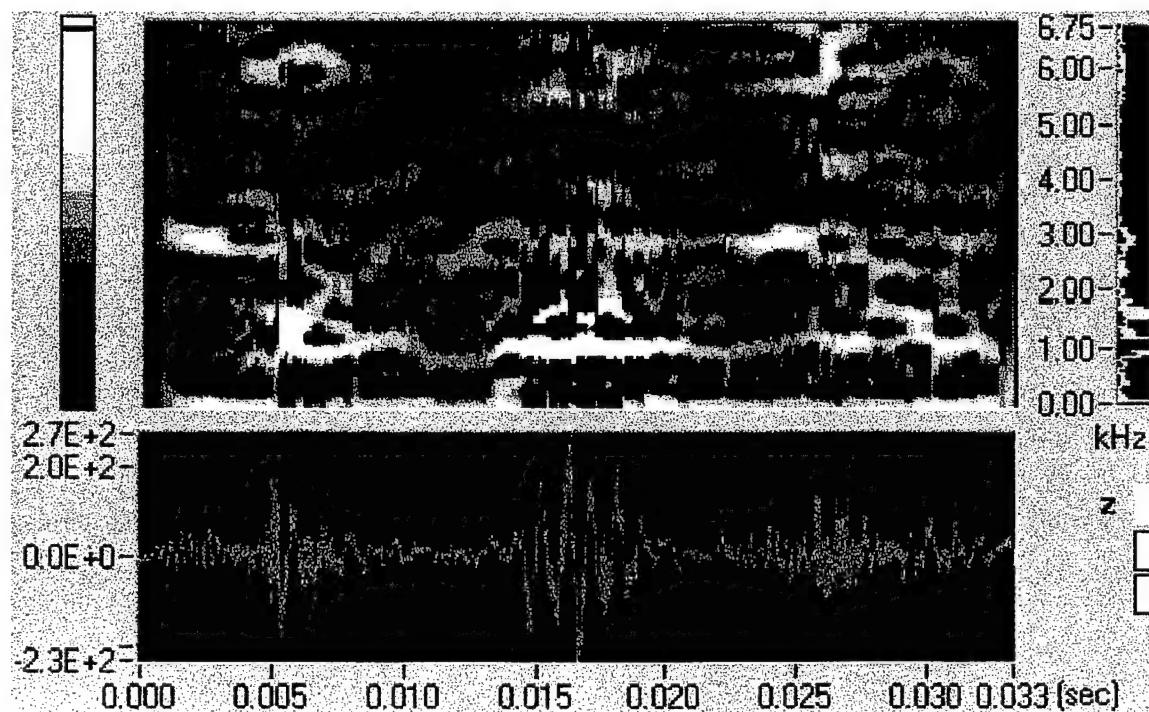
Figure 4.9 shows the CSD of the baseline vibration signal. The timing fault condition vibration signal is shown in Figure 4.10. These CSD figures show good frequency resolution but poor time resolution. The horizontal stripes provide narrow frequency band information but do not distinguish the location in time clearly. The effects of cross term interference and noise are present again, but less than the distortion levels in the WVD. The CSD provides little or no useful information in determining the differences between the baseline and timing fault signals.

Figure 4.9 Cone-Shaped Distribution of the engine baseline vibration signal

Figure 4.10 Cone-Shaped Distribution of the engine timing fault condition vibration signal

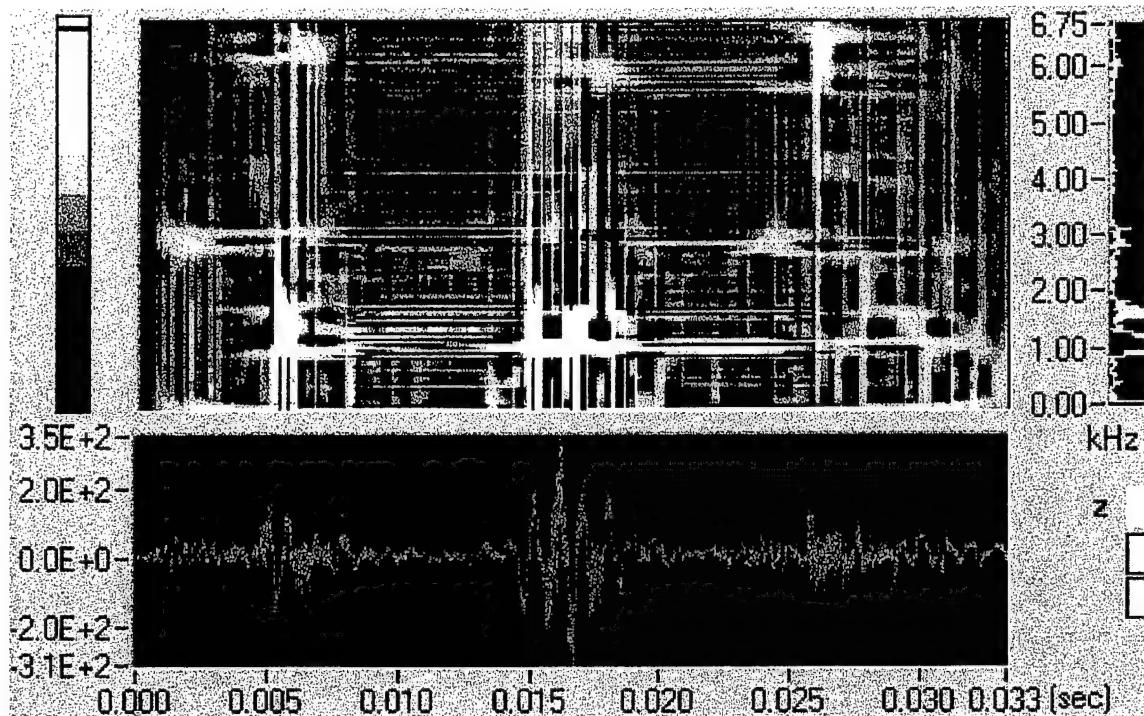
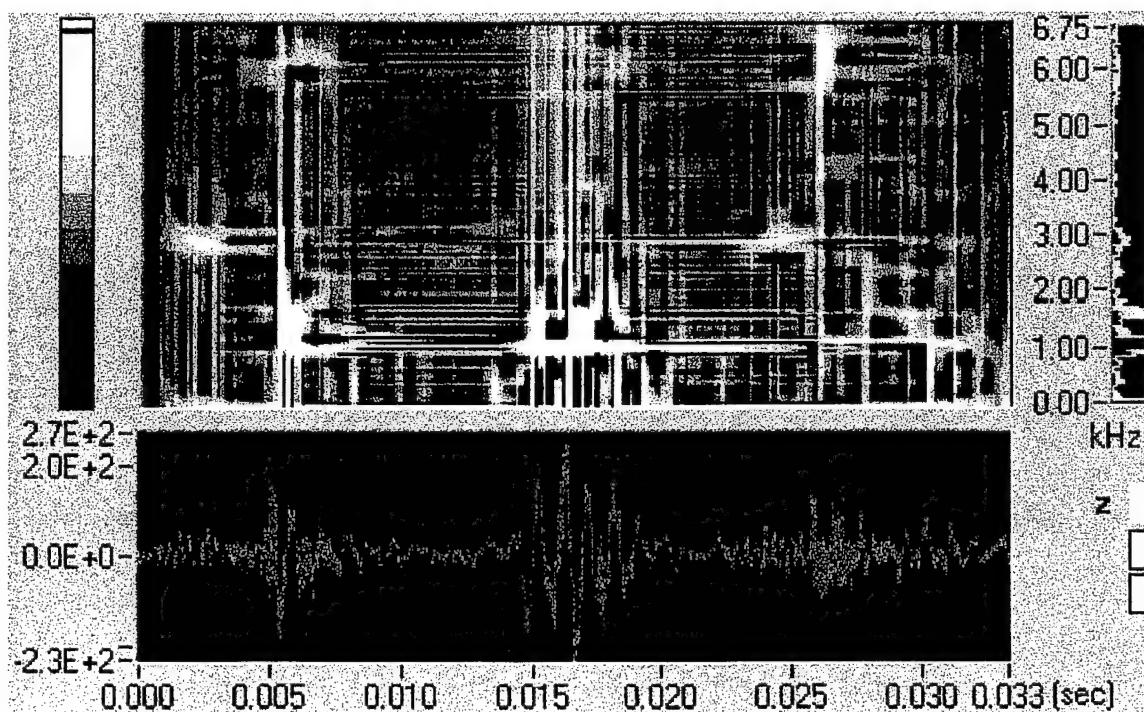
Figure 4.11 shows the CWD of the baseline vibration signal. The timing fault condition vibration signal is shown in Figure 4.12. These CWD figures show excellent time and frequency resolution in the very narrow horizontal and vertical bands. However, the cross term interference and noise creates even more distortion than the CSD or Gabor Spectrogram. The CWD provides little or no useful information in determining the differences between the baseline and timing fault signals.

Figure 4.11 Choi-Williams Distribution of the engine baseline vibration signal

Figure 4.12 Choi-Williams Distribution of the engine timing fault condition vibration signal

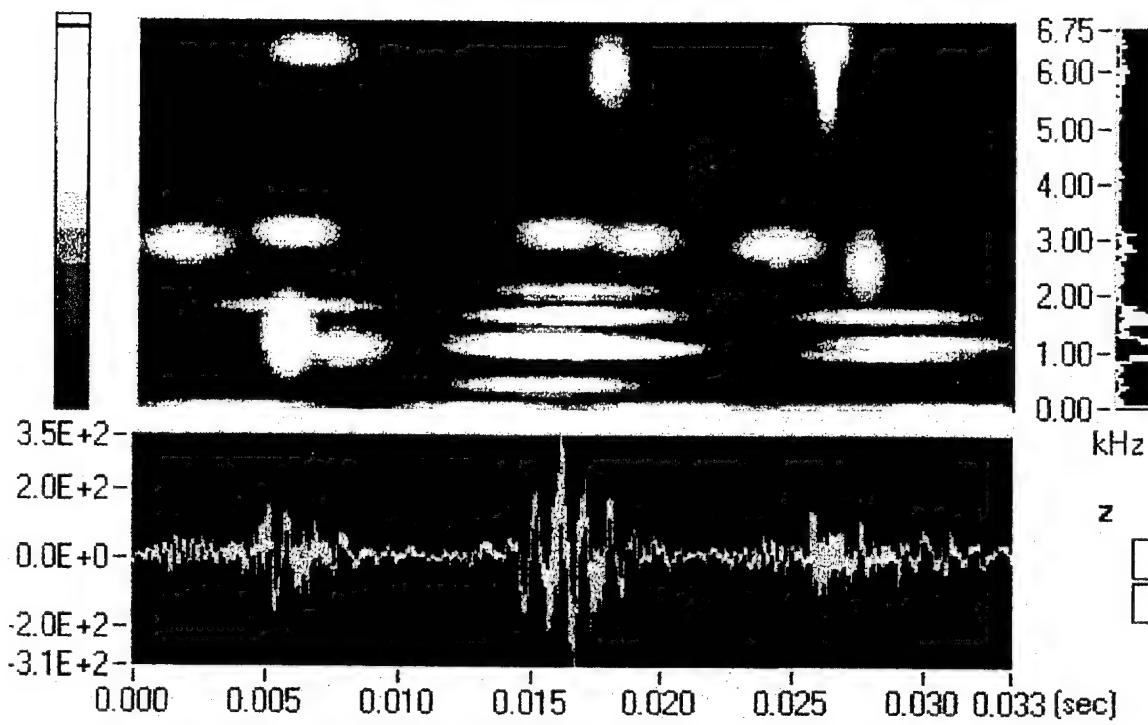
Figure 4.13 shows the ASD of the baseline vibration signal. The timing fault condition vibration signal is shown in Figure 4.14. The Joint Time Frequency Distribution shows localized energy peaks or islands with respect to time and frequency. As you would expect from examining the time domain vibration signal, the energy is concentrated in the time periods where each cylinder is firing. Since the vibration transducer is directly above the first cylinder, there are more islands displayed between 0.010-0.020 seconds. The magnitudes of these first cylinder islands are greater than those associated with the second and third cylinder firings. Some minor shifting or shape changes of the islands was found by comparing multiple data runs. Increasing the number of revolutions being sampled and averaged should increase the stability of the energy islands.

Now focus in on the period where the first cylinder is firing 0.010-0.020 seconds. There are several clear and distinct time-frequency peaks or islands at 0.5, 1.0, 1.5, 2.0, 3.0 and 6.0 khz. Exactly what each frequency island corresponds to in the engine is unknown and will require further study. The firing of the cylinder acts like a big hammer striking the engine. This impulse will undoubtedly cause many of the engine components to resonate at their individual natural frequencies. Some of the likely sources are the

Figure 4.13 Adaptive Spectrogram of the engine baseline vibration signal

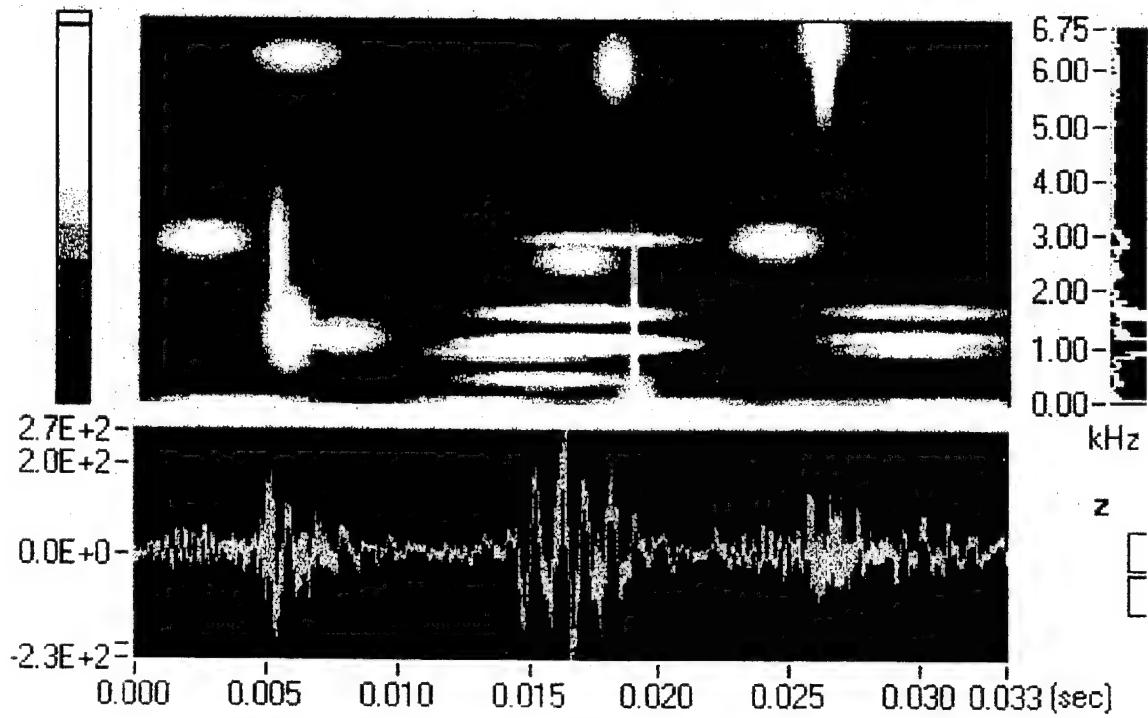
Figure 4.14 Adaptive Spectrogram of the engine timing fault condition vibration signal

Directly comparing the ASD of the baseline and fault condition signals, there is one feature which is clearly different. Figure 4.14 shows a broadband of energy at 0.018 seconds ranging from 0 to 3.5 khz. This feature does not occur in the baseline Figure 4.13. This broadband of energy could be the signature of a change in the combustion process due to the timing shift. This same broadband “scar” was found in all four of the data runs with the timing fault and did not appear in any of the four baseline data runs.
